## Inspection Report Minerals Regulatory Program Report Date: November 9, 2004

**Mine Name:** Unpermitted--State Stone

**Permit number:** S/055/021

**ATTACHMENT**  
**Photographs**  
**M/055/021 (Unpermitted), State Stone**  
Inspection Dated: November 4, 2004 ; Report Dated: November 9, 2004

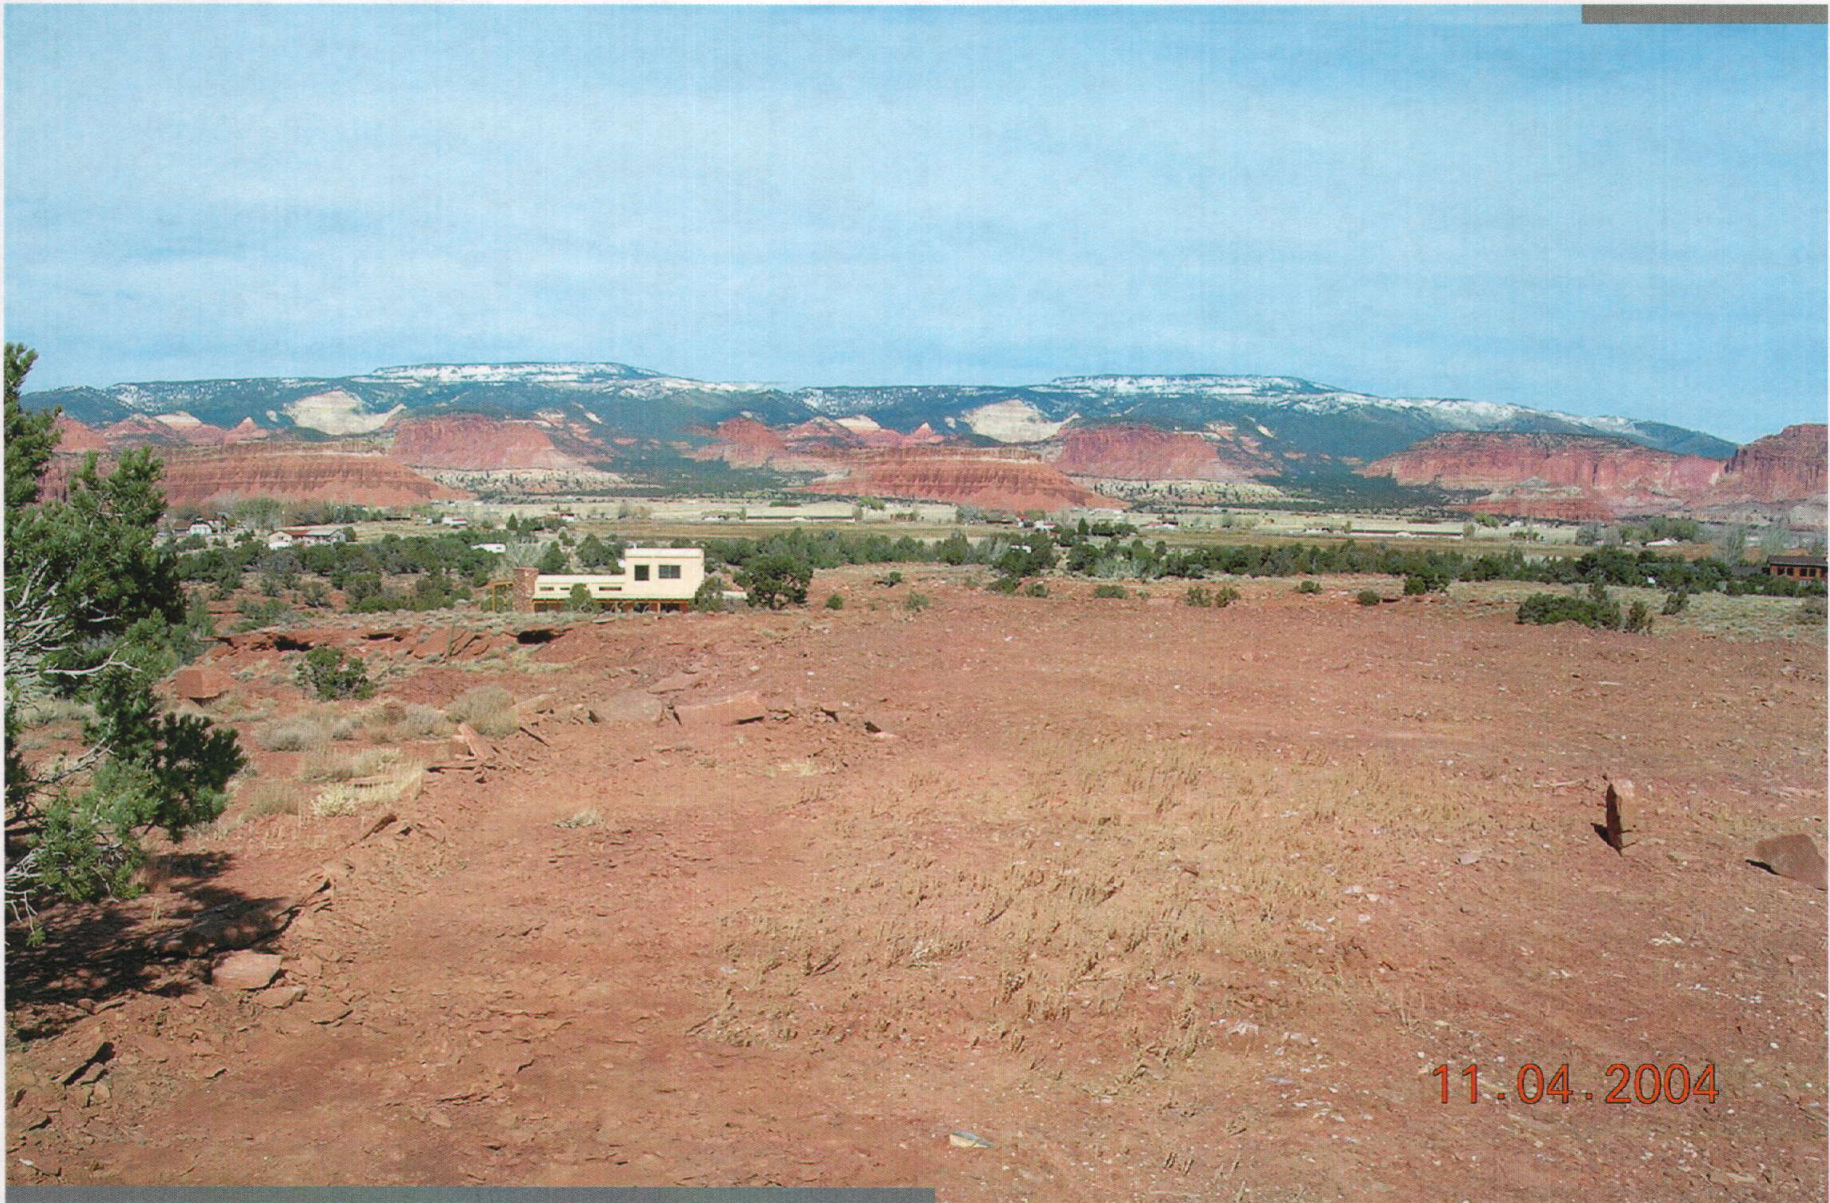
At the west quarry, the processing/loading area has been regraded (Photo 1). I used a GPS unit to map the area that still needs to be reclaimed, and it is 1.02 acres. Mr. MacKay told me he does not have permission to mine in the southernmost portion of the area (the 0.15-acre area mentioned above). This area is shown in Photo 2.

**Photo 1. The reggraded loading/processing area at the west quarry.**

The regraded areas need to be roughened and seeded. Seeding should be done as soon as possible after surface preparation. I furnished the operator with a recommended seed mix.

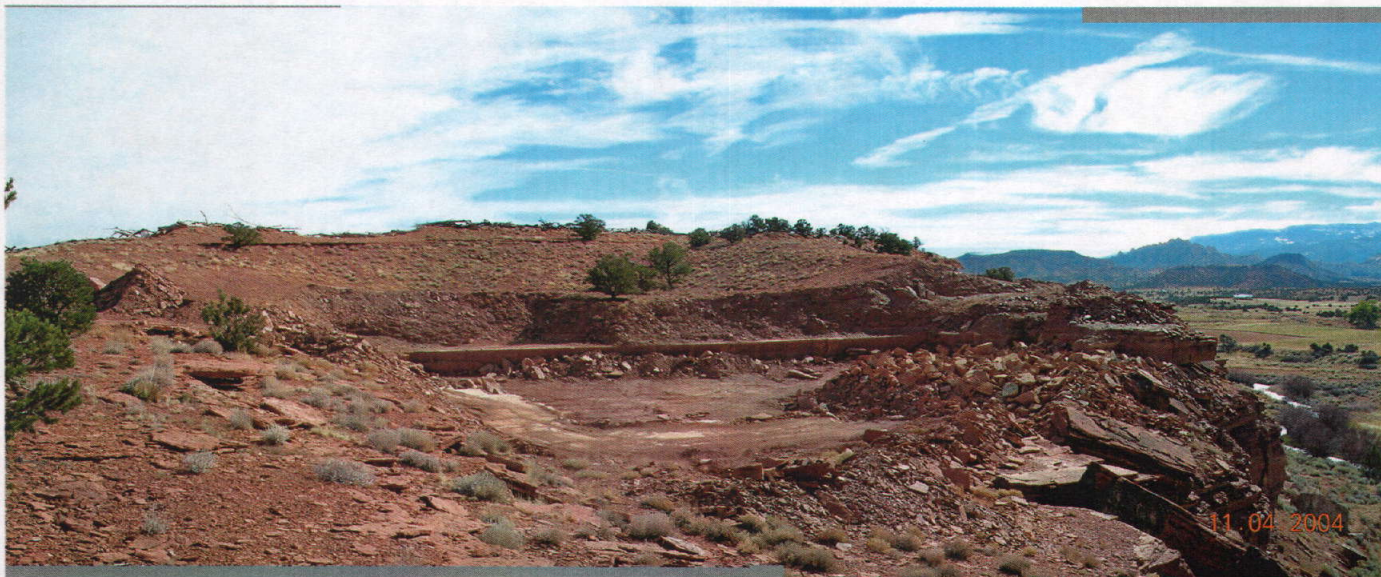
**Photo 2. The quarry area at the west quarry. This is a composite of three photographs and has some distortion.**

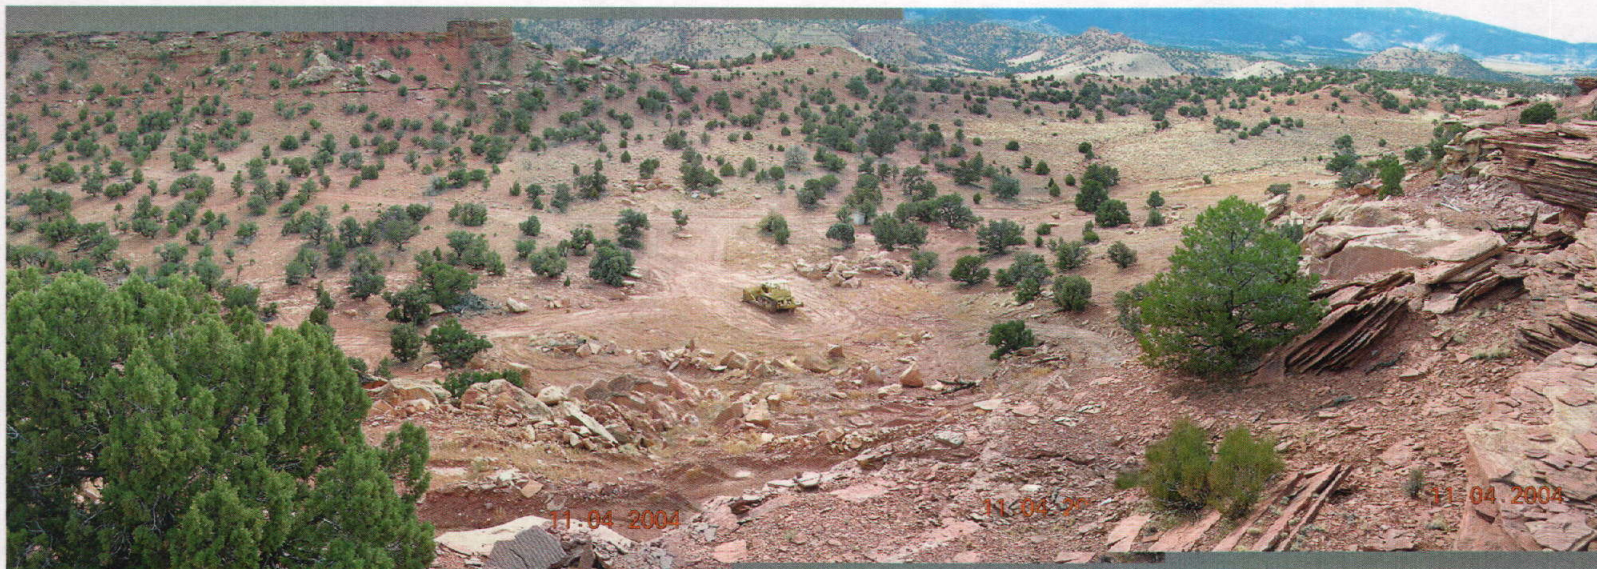
Grading has also been completed at the east quarry (Photo 3), and the operator put out T-posts to mark the disturbed area. This was done in accordance with our discussions last April when the area to be used for future mining operations was measured as 3.96 acres.

**Photo 3. Panorama of the east quarry. While this is a composite of three photographs, there is little distortion.**

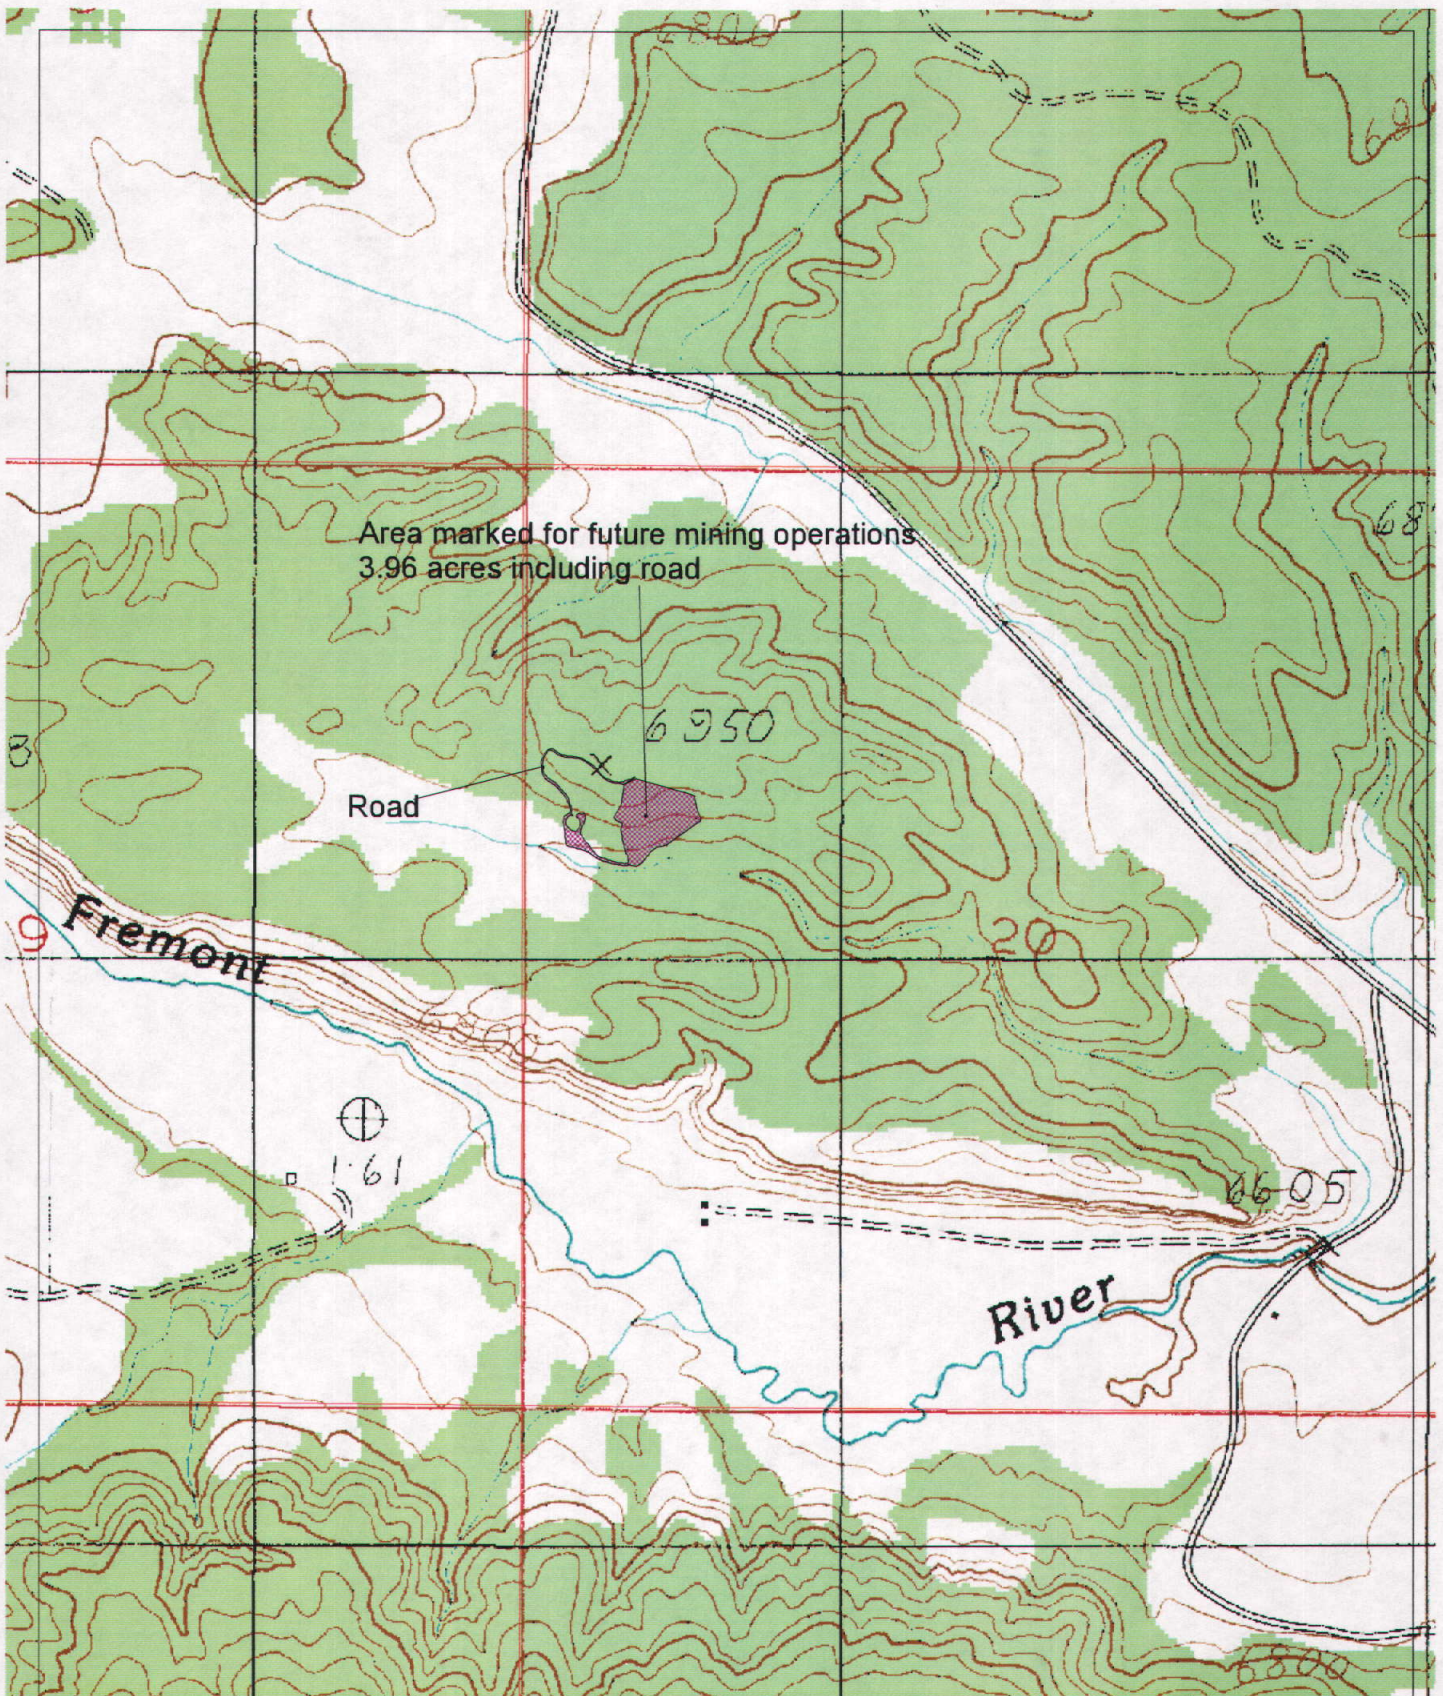
Mine Number: M/055/021 (East Site)  
Mine Name: State Stone  
Township 29 S Range 5 E Section 20 SLBM  
Torrey Quad

Attached to this report are maps created using data gathered at the west quarry during this inspection and at the east quarry during an inspection last April. The map of the west quarry includes points at three stakes. Mr. MacKay thought these stakes show the boundary of the Jensen's property and that they were placed during a survey of the property. I cannot verify whether this is correct. The map of the west quarry is as accurate as I can make it, but since I am not a surveyor and did not use a survey-grade GPS unit, I cannot certify that the points are absolutely accurate.
